## **Section 2.0 – Site Evaluation and Selection**

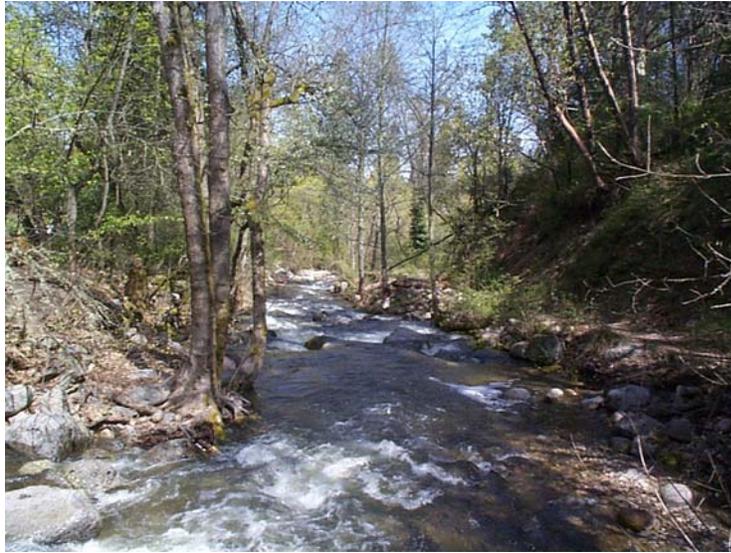
Figure 2-1: A potential riparian plant reference location.

The first step in the successful establishment of a healthy riparian area is to note what species are presently growing and what species were found historically in the area. Existing and historic riparian vegetation indicate which species are likely to grow well on the site, and also provide valuable insight to the area's soils and hydrology. In addition, shade survey data (e.g., PIPPS 1999) can be used with air photo interpretation to evaluate existing shade conditions with potential conditions. The larger the percentage change in shade, the higher weight the site should have for planting.

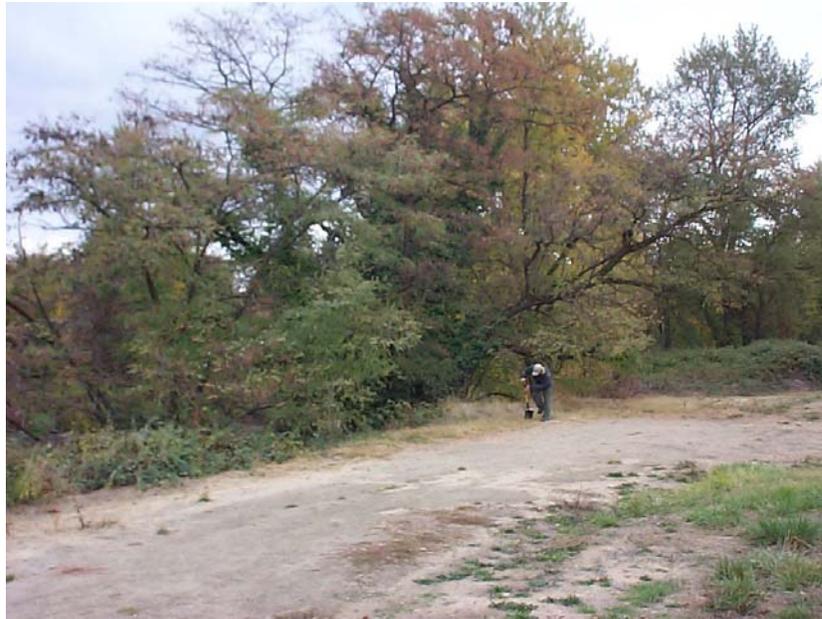
Figure 2-2: Potential planting area with compact soils.

In some cases, urban soils may have an upper soil layer devoid of organic material and contain mixtures of backfill soils, construction debris, and other non-indigenous soil compositions that are devoid of nutrients. Soil aeration and compost application may help remedy soil problems and is considered for particular sites. Additionally, soils that have been compacted due to livestock grazing or heavy equipment traffic can develop a relatively impermeable compact layer that restricts water movement and root development.

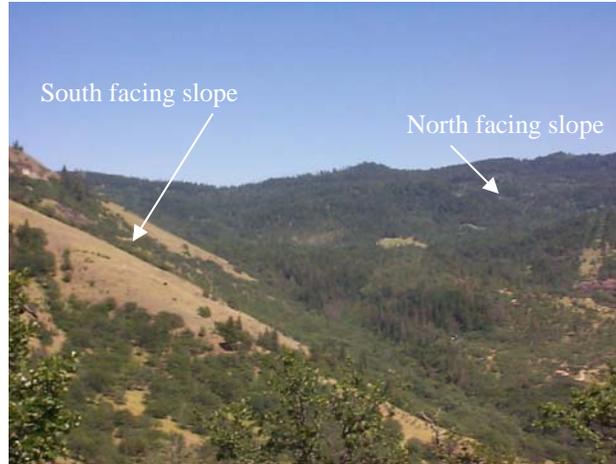
Figure 2-3: Vegetation differences between south facing and north facing slopes.

Site aspect influences the amount of sunlight and moisture sites receive. South-facing slopes are hotter and drier because they receive more sun. North slopes receive less sunlight and are correspondingly cooler and moisture than southern slopes.

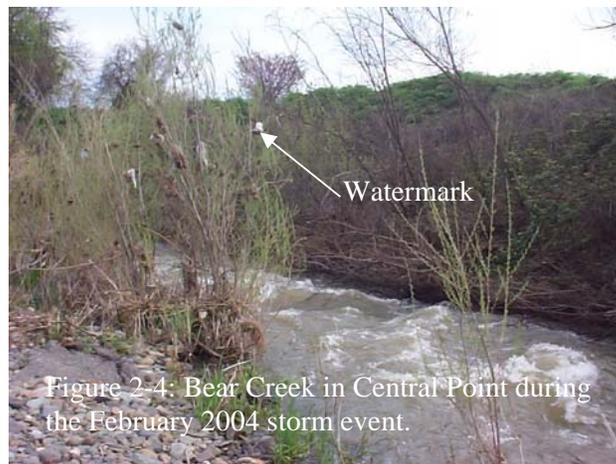
Figure 2-4: Bear Creek in Central Point during the February 2004 storm event.

The frequency of flooding is evaluated at each site noting the presence of high watermarks, drift lines, sediment deposition, bankfull depths, and FEMA floodplain maps. Flooding encourages deep rooting by trees and reduces the necessity for long-term irrigation. In flood prone areas plants that can tolerate inundation are selected such as alders, dogwoods, cottonwoods and willows. A site that is infrequently flooded will accommodate different plant species, such as elderberry and conifers, and may require more irrigation.
