Rogue Drinking Water Providers Source Water Protection Plan

NRCS National Water Quality Initiative

Prepared by Greg Stabach and Amie Siedlecki,
Rogue Valley Council of Governments
In partnership with NRCS and John Speece,
Rogue River Watershed Council

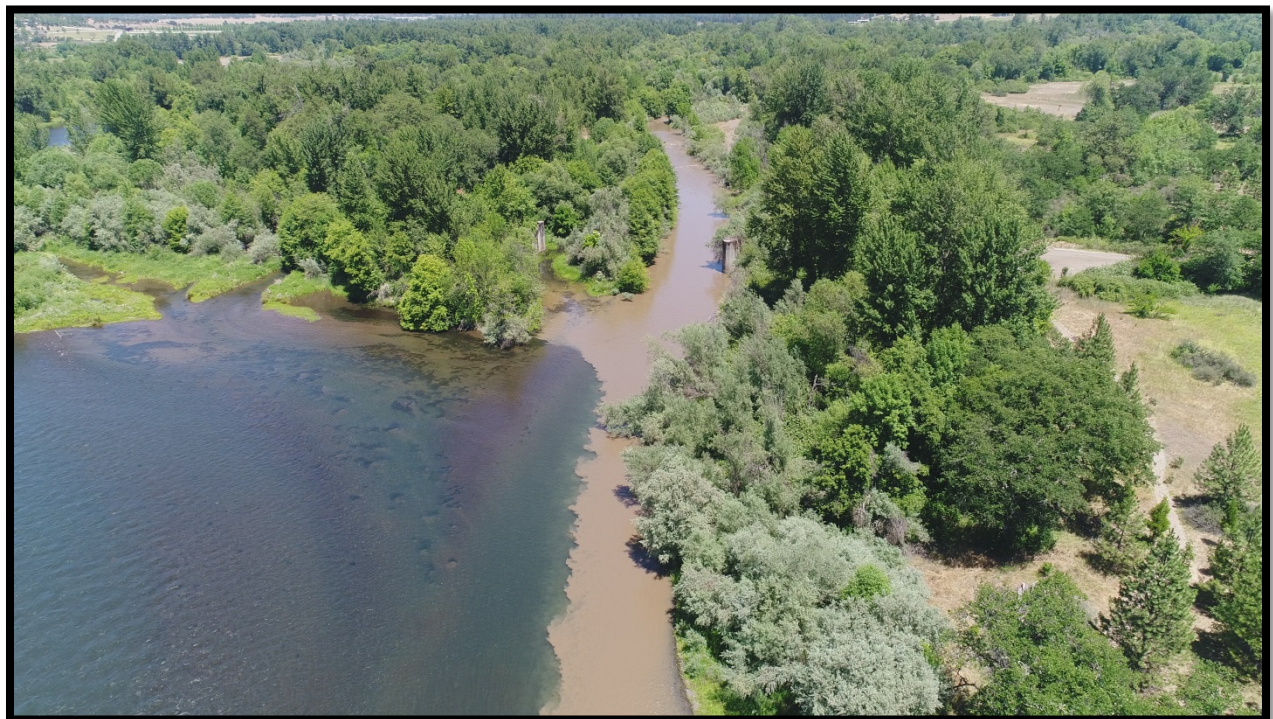
Four recent landslides have been documented in the project area as shown in Figure 3.3. Two of the landslides occurred in the Indian Creek Basin and two in the Whetstone Creek Basin. In addition, a debris slide occurred in June of 2018 in the upper Little Butte Creek Basin (MWC, 2021), and the impacts of that debris slide can be seen in Figure 3.4 below.

Figure 3.4: Turbidity Plume Entering the Rogue River from Little Butte Creek
